**Flood Control Project Maintenance  
Levee Inspections**

## Maintenance Issue Types Only, Levee Inspection Report By Mile - Spring 2019

### Reclamation District No. 0524 Middle Roberts Island

Waterway	Bank	Unit Miles	Inspection Start/End	Inspector
Unit No. 01 San Joaquin River	Left	6.20	03/26/2019 03/27/2019	Alberto De Leon

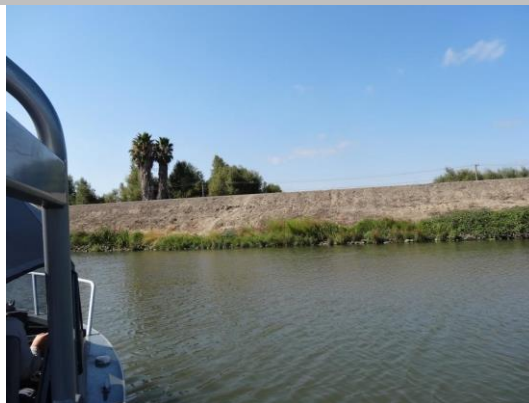
Photo 2 of 3 : SP\_2019\_RD0524\_107\_1\_20190313\_00002.jpg

LM Start	<b>0.19</b>	Rating **	U	Issue No.	<b>1 (cont)</b>
LM End	<b>0.19</b>	Issue Type +	Ma	Location *	WS

Front view of the erosion.

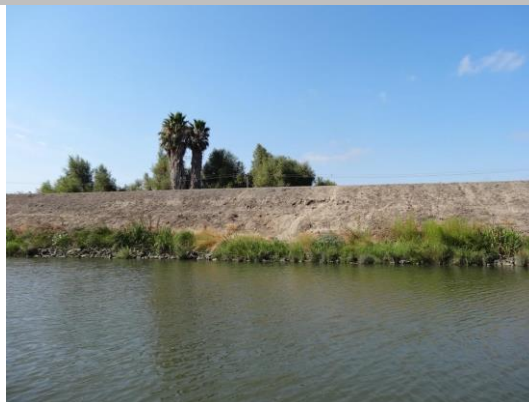
Photo 3 of 3 : SP\_2019\_RD0524\_107\_1\_20190313\_00003.jpg

Front view of the erosion.

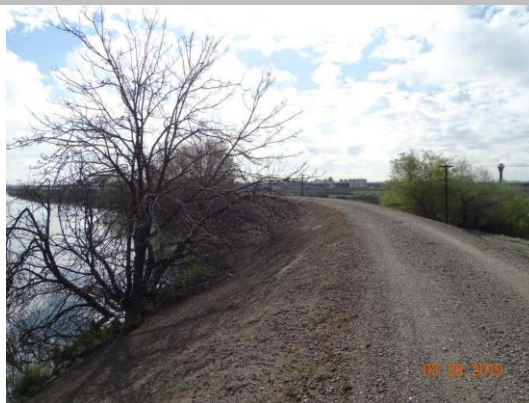
Photo 1 of 2 : SP\_2019\_RD0524\_107\_201\_20190328\_00390.jpg

LM Start	0.23	Rating **	M	Issue No.	201
LM End	0.23	Issue Type +	Ma	Location *	WS
Category	Earthen Levee			GPS Latitude/Longitude	
				Start	End
Item	Trim / Thin Trees			37.938648 °	37.938648 °
				-121.343480 °	-121.343480 °
DWR ID	DWR_RD0524_01_f_2016_201				
Comment Code					
T1 : Trim trees to at least five feet above ground level.					
Inspector Comment

View of tree on waterside slope looking upstream. Spring 2019.

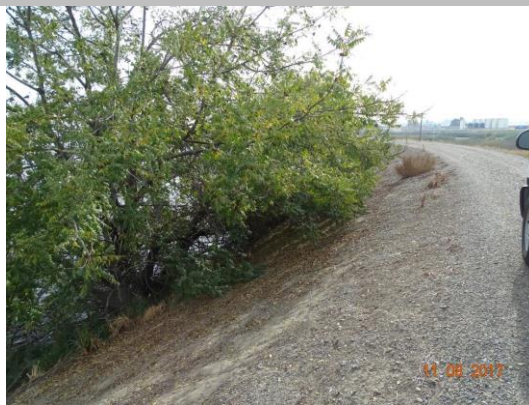
Photo 2 of 2 : SP\_2019\_RD0524\_107\_201\_20190313\_00208.jpg

Looking southeast at the waterside slope.

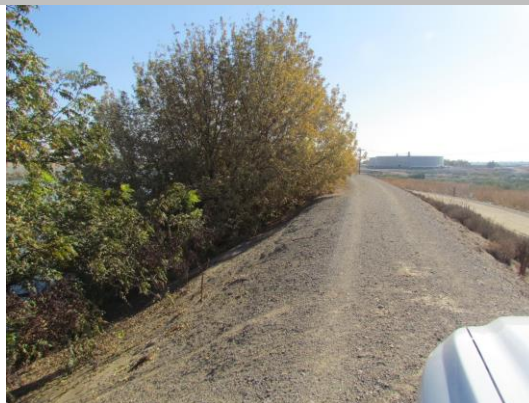
Photo 1 of 1 : SP\_2019\_RD0524\_107\_179\_20190313\_00183.jpg

LM Start	0.27	Rating **	U	Issue No.	179	
LM End	0.27	Issue Type +	Ma	Location *	WS	
Category	Earthen Levee			GPS Latitude/Longitude		
				Start		End
Item	Trim / Thin Trees			37.938438 °		37.938438 °
				-121.342883 °		-121.342883 °
DWR ID	DWR_RD0524_01_s_2014_179					
Comment Code						
T3 : Trim and thin trees to allow visibility of the ground and room to flood fight.						
Inspector Comment						
Tree blocking view of waterside slope.

Looking east at untrimmed tree on waterward slope. (Fall 2016)

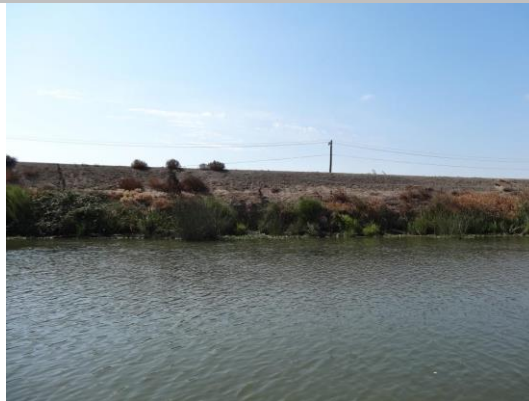
Photo 1 of 4 : SP\_2019\_RD0524\_107\_2\_20190313\_00004.jpg

LM Start	0.34	Rating **	M	Issue No.	2
LM End	0.34	Issue Type +	Ma	Location *	WS
Category	Supplemental			GPS Latitude/Longitude	
				Start	End
Item	DWR Erosion Survey			37.938461 °	37.938461 °
				-121.341526 °	-121.341526 °
DWR ID	RD0524U01RM40.93				
Comment Code					
Inspector Comment					
09/13/2017: There are two pocket erosions at the site; both erosions are around 10 ft long and 6 ft high. [2017 Site ID:RD0524U01RM40.93]

Front view of the erosion site.

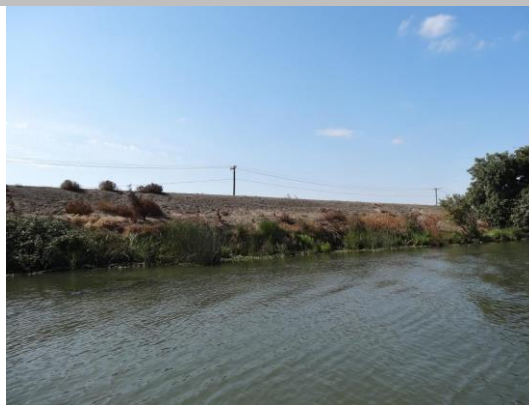
Photo 2 of 4 : SP\_2019\_RD0524\_107\_2\_20190313\_00005.jpg

Looking downstream of the erosion.

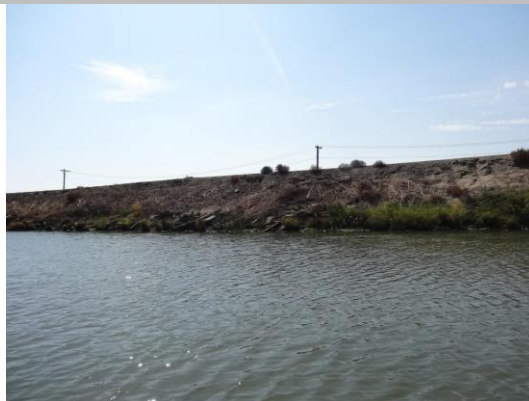
Photo 3 of 4 : SP\_2019\_RD0524\_107\_2\_20190313\_00006.jpg

Close view of the erosion site.

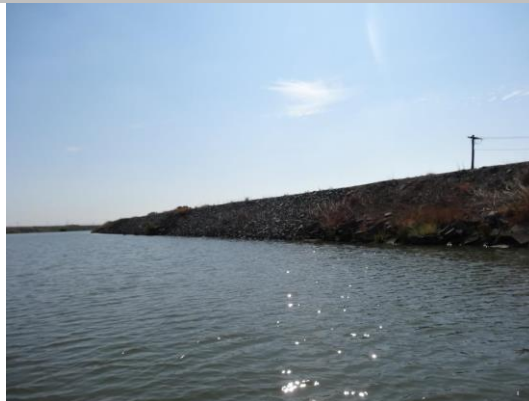
Photo 2 of 4 : SP\_2019\_RD0524\_107\_5\_20190313\_00009.jpg

LM Start	0.40	Rating **	M	Issue No.	5 (cont)	
LM End	0.40	Issue Type +	Ma	Location *	WS	
Category	Supplemental			GPS Latitude/Longitude		
				Start		End
Item	DWR Erosion Survey			37.938870 °		37.938870 °
				-121.340460 °		-121.340460 °
DWR ID	RD0524U01RM40.99					
Comment Code						
Inspector Comment						
09/13/2017: No significant change observed.						
07/25/2016: More vegetation observed at the site.						
06/24/2015: No significant change observed.						
06/19/2014: No significant change observed.						
08/13/2013: No significant change at this site.						
08/07/2012: The erosion is at the upper levee slope, and likely caused by slope slip. The lower levee slope is covered with dense vegetation.						
[2017 Site ID:RD0524U01RM40.99]

Downstream view of the site.

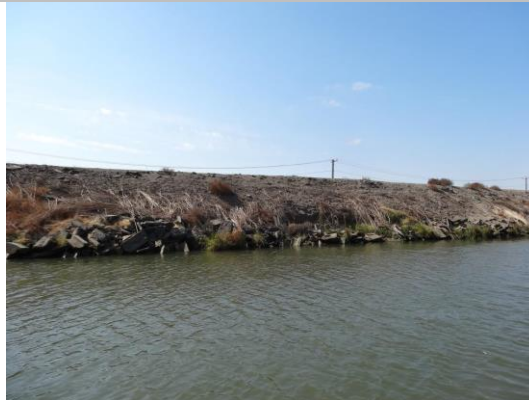
Photo 3 of 4 : SP\_2019\_RD0524\_107\_5\_20190313\_00010.jpg

Close view of the erosion.

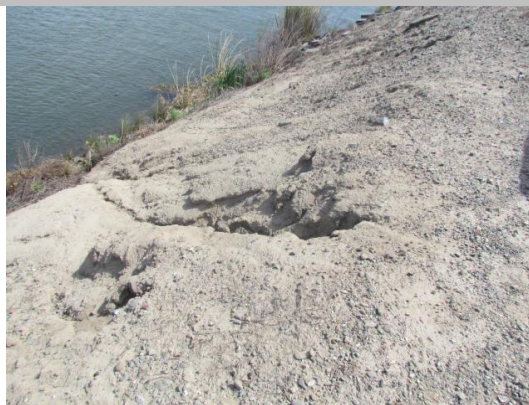
Photo 3 of 3 : SP\_2019\_RD0524\_107\_170\_20190313\_00175.jpg

LM Start	0.43	Rating **	M	Issue No.	170 (cont)	
LM End	0.43	Issue Type +	Ma	Location *	WS	
Category	Earthen Levee			GPS Latitude/Longitude		
				Start		End
Item	Erosion / Bank Caving			37.938669 °		37.938669 °
				-121.340006 °		-121.340006 °
DWR ID	DWR_RD0524_01_s_2015_170					
Comment Code						
E2 : Schedule repair of erosion site prior to the next inspection.						
Inspector Comment						
Erosion on waterside toe, exposed area does not have rip rap

Looking at waterward slope erosion.

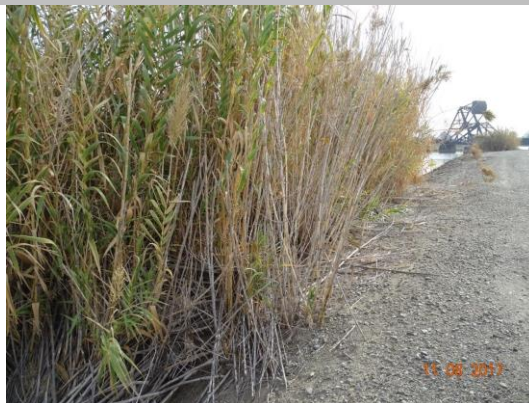
Photo 2 of 2 : SP\_2019\_RD0524\_107\_11\_20190313\_00014.jpg

LM Start	0.63	Rating **	U	Issue No.	11 (cont)	
LM End	0.64	Issue Type +	Ma	Location *	WS	
Category	Earthen Levee			GPS Latitude/Longitude		
				Start		End
Item	Vegetation			37.938232 °		37.938160 °
				-121.336484 °		-121.336357 °
DWR ID	DWR_RD0524_01_s_2012_11					
Comment Code						
V2 : Remove the wild growth other than native grasses from the levee slopes.						
Inspector Comment						
Arrundo on waterside slope

Looking southeast at the waterside slope.

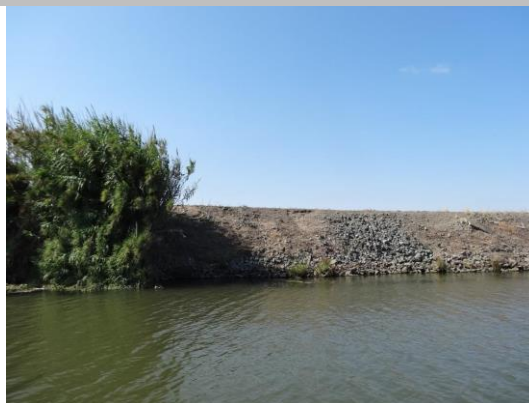
Photo 1 of 2 : SP\_2019\_RD0524\_107\_15\_20190313\_00017.jpg

LM Start	0.63	Rating **	M	Issue No.	15
LM End	0.63	Issue Type +	Ma	Location *	WS
Category	Supplemental			GPS Latitude/Longitude	
				Start	End
Item	DWR Erosion Survey			37.938247 °	37.938247 °
				-121.336503 °	-121.336503 °
DWR ID	RD0524U01RM41.26				
Comment Code					
Inspector Comment					
09/13/2017: The erosion was discovered by levee inspection. The erosion site is immediately downstream of tall vegetations. [2017 Site ID:RD0524U01RM41.26]

Front view of the erosion. The erosion is located at the shadow of the vegetation.

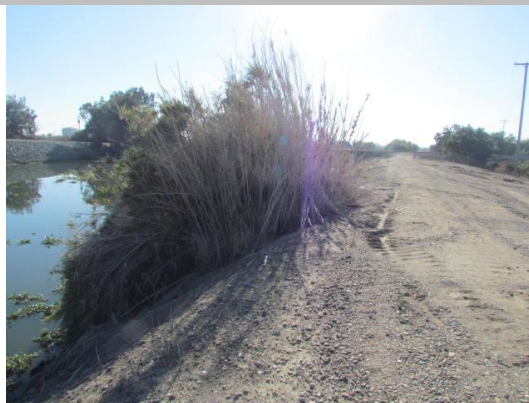
Photo 1 of 1 : SP\_2019\_RD0524\_107\_14\_20190313\_00016.jpg

LM Start	0.67	Rating **	U	Issue No.	14
LM End	0.67	Issue Type +	Ma	Location *	WS
Category	Earthen Levee			GPS Latitude/Longitude	
				Start	End
Item	Vegetation			37.937808 °	37.937808 °
				-121.335913 °	-121.335913 °
DWR ID	DWR_RD0524_01_s_2012_14				
Comment Code					
V2 : Remove the wild growth other than native grasses from the levee slopes.					
Inspector Comment					
Arundo on waterside slope

Looking south at dying bamboo on waterward slope. Fall 2015

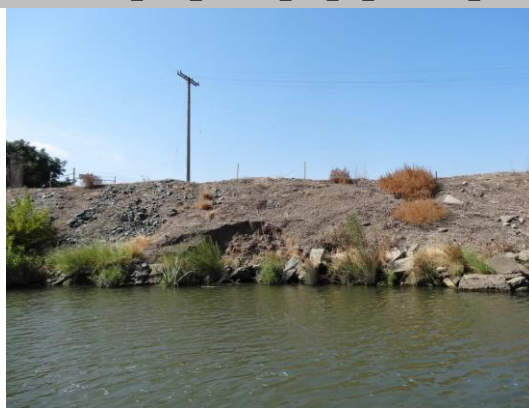
Photo 1 of 4 : SP\_2019\_RD0524\_107\_16\_20190313\_00019.jpg

LM Start	0.70	Rating **	M	Issue No.	16
LM End	0.70	Issue Type +	Ma	Location *	WS
Category	Supplemental			GPS Latitude/Longitude	
				Start	End
Item	DWR Erosion Survey			37.937577 °	37.937577 °
				-121.335491 °	-121.335491 °
DWR ID	RD0524U01RM41.34				
Comment Code					
Inspector Comment					
09/13/2017: Pocket erosion above the protected levee toe. [2017 Site ID:RD0524U01RM41.34]

Front view of the erosion.

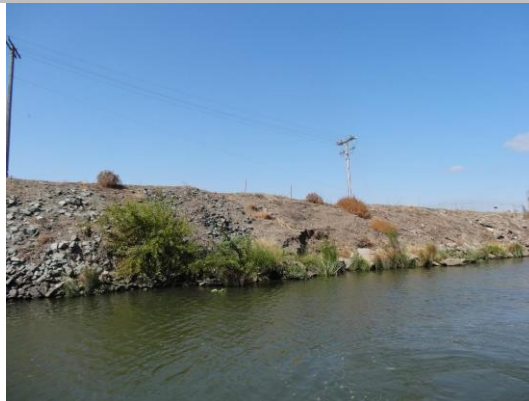
Photo 3 of 4 : SP\_2019\_RD0524\_107\_16\_20190313\_00021.jpg

LM Start	0.70	Rating **	M	Issue No.	16 (cont)	
LM End	0.70	Issue Type +	Ma	Location *	WS	
Category	Supplemental			GPS Latitude/Longitude		
				Start	End	
Item	DWR Erosion Survey			37.937577 °	37.937577 °	
				-121.335491 °	-121.335491 °	
DWR ID	RD0524U01RM41.34					
Comment Code						
Inspector Comment						
09/13/2017: Pocket erosion above the protected levee toe. [2017 Site ID:RD0524U01RM41.34]

Looking downstream of the erosion site.

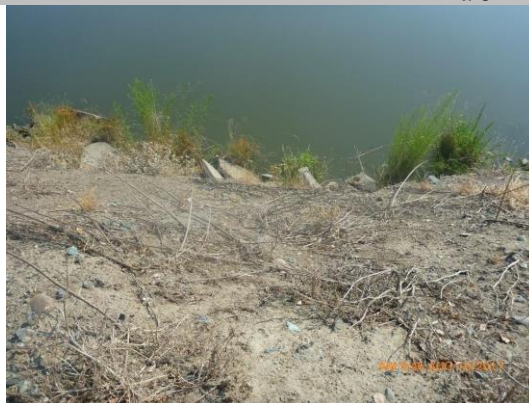
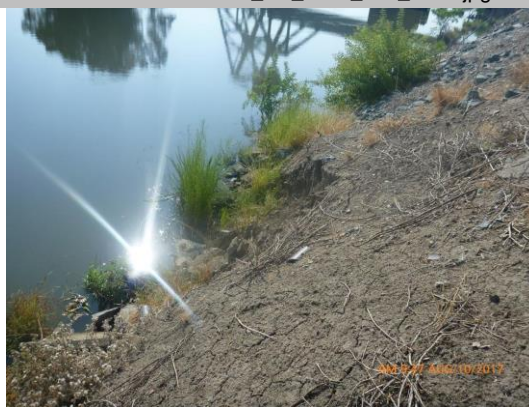
LM Start	<b>0.70</b>	Rating **	A/W	Issue No.	<b>153</b>
LM End	<b>0.70</b>	Issue Type +	Ma	Location *	
Category	Supplemental		GPS Latitude/Longitude		
			Start	End	
Item	2017 Storm Damage		37.937500 °	37.937500 °	
			-121.335500 °	-121.335500 °	
DWR ID	DWR_RD0524_01_f_2017_153				
Comment Code					
Inspector Comment					
<p>Levee Evaluation Comments</p> <p>Description: Slope protection repairs are needed along the waterside slope due to erosion and riprap displacement from high water. Based upon levee inspections, it was determined the waterside levee slope is eroding, deteriorating, and degrading. The eroded levee sections need to be restored back to design standards to prevent further deterioration and damage.</p> <p>Site ID No: 541</p> <p>Site Designation: LMA-447</p> <p>Repair Type: Erosion</p> <p>Rating: Area of Concern</p> <p>Field Date: 8/10/2017</p> <p>Notes:</p>

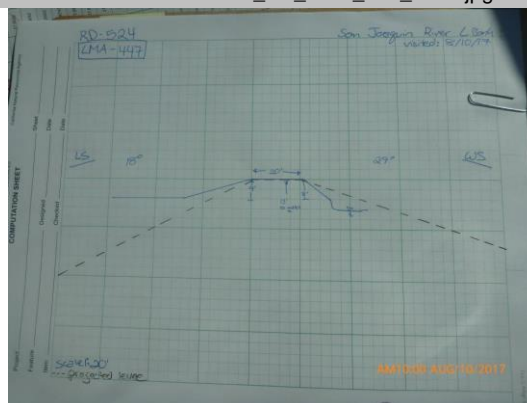
Photo 3 of 3 : LEVAL\_SP\_2019\_541\_4083.jpg

LM Start	0.70	Rating **	A/W	Issue No.	153 (cont)
LM End	0.70	Issue Type +	Ma	Location *	
Category	Supplemental			GPS Latitude/Longitude	
				Start	End
Item	2017 Storm Damage			37.937500 °	37.937500 °
				-121.335500 °	-121.335500 °
DWR ID	DWR_RD0524_01_f_2017_153				
Comment Code					
Inspector Comment					
Levee Evaluation Comments					
Description:Slope protection repairs are needed along the waterside slope due to erosion and riprap displacement from high water. Based upon levee inspections, it was determined the waterside levee slope is eroding, deteriorating, and degrading. The eroded levee sections need to be restored back to design standards to prevent further deterioration and damage.					
Site ID No:541					
Site Designation:LMA-447					
Repair Type: Erosion					
Rating:Area of Concern					
Field Date:8/10/2017					
Notes:

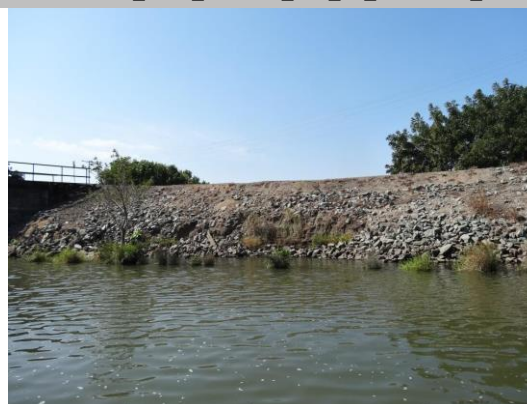
Photo 1 of 3 : SP\_2019\_RD0524\_107\_17\_20190313\_00023.jpg

LM Start	0.71	Rating **	M	Issue No.	17
LM End	0.73	Issue Type +	Ma	Location *	WS
Category	Supplemental			GPS Latitude/Longitude	
				Start	End
Item	DWR Erosion Survey			37.937222 °	37.937222 °
				-121.335277 °	-121.335277 °
DWR ID	RD0524U01RM41.36				
Comment Code					
Inspector Comment					
09/13/2017: No significant change observed.					
07/25/2016: No significant change observed.					
06/24/2015: The erosion site is immediately downstream of the RR bridge. [2017 Site ID:RD0524U01RM41.36]

Front view of the erosion.

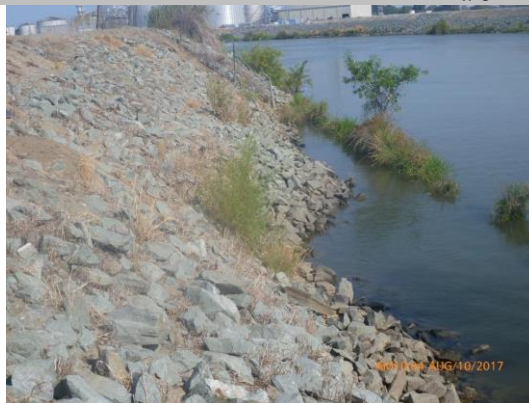
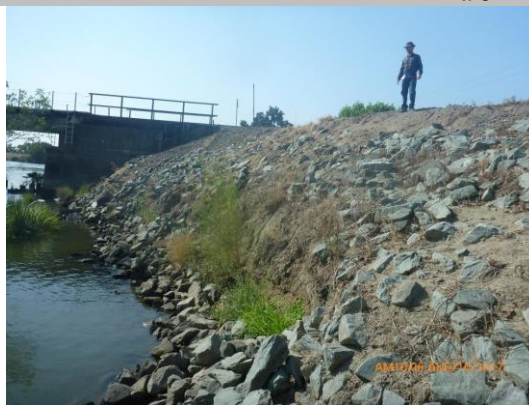
LM Start	0.72	Rating **	A/W	Issue No.	154
LM End	0.73	Issue Type +	Ma	Location *	
Category	Supplemental			GPS Latitude/Longitude	
				Start	End
Item	2017 Storm Damage			37.937200 °	37.937100 °
				-121.335300 °	-121.335300 °
DWR ID	DWR_RD0524_01_f_2017_154				
Comment Code					
Inspector Comment					
Levee Evaluation Comments					
Description:Slope protection repairs are needed along the waterside slope due to erosion and riprap displacement from high water. Based upon levee inspections, it was determined the waterside levee slope is eroding, deteriorating, and degrading. The eroded levee sections need to be restored back to design standards to prevent further deterioration and damage.					
Site ID No:540					
Site Designation:LMA-446					
Repair Type: Erosion					
Rating:Area of Concern					
Field Date:8/10/2017					
Notes:

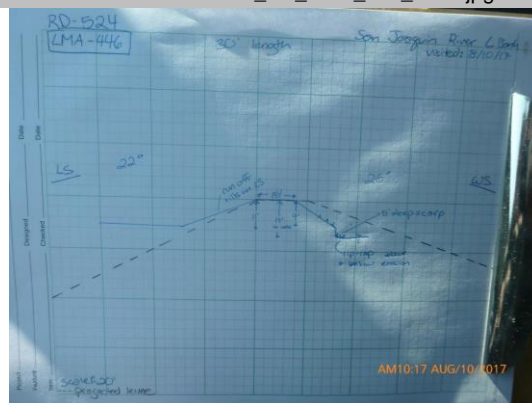
Photo 3 of 3 : LEVAL\_SP\_2019\_540\_4089.jpg

LM Start	0.72	Rating **	A/W	Issue No.	154 (cont)
LM End	0.73	Issue Type +	Ma	Location *	
Category	Supplemental			GPS Latitude/Longitude	
				Start	End
Item	2017 Storm Damage			37.937200 °	37.937100 °
				-121.335300 °	-121.335300 °
DWR ID	DWR_RD0524_01_f_2017_154				
Comment Code					
Inspector Comment					
Levee Evaluation Comments					
Description:Slope protection repairs are needed along the waterside slope due to erosion and riprap displacement from high water. Based upon levee inspections, it was determined the waterside levee slope is eroding, deteriorating, and degrading. The eroded levee sections need to be restored back to design standards to prevent further deterioration and damage.					
Site ID No:540					
Site Designation:LMA-446					
Repair Type: Erosion					
Rating:Area of Concern					
Field Date:8/10/2017					
Notes:

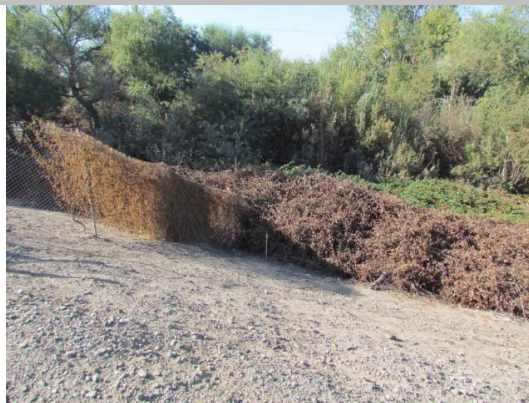
Photo 2 of 3 : SP\_2019\_RD0524\_107\_262\_20190313\_00273.jpg

LM Start	0.75	Rating **	U	Issue No.	262
LM End	0.78	Issue Type +	Ma	Location *	LS
Category	Earthen Levee			GPS Latitude/Longitude	
				Start	End
Item	Vegetation			37.936813 °	37.936539 °
				-121.335019 °	-121.334863 °
DWR ID	DWR_RD0524_01_s_2012_262				
Comment Code					
V2 : Remove the wild growth other than native grasses from the levee slopes.					
Inspector Comment					
Dense vegetation at landside toe along fence line.

Looking west at dense vegetation at landward slope and toe fall 2015.

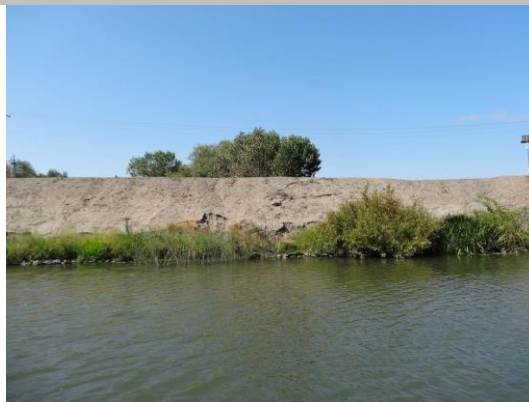
Photo 2 of 4 : SP\_2019\_RD0524\_107\_21\_20190313\_00031.jpg

LM Start	0.76	Rating **	U	Issue No.	21
LM End	0.77	Issue Type +	Ma	Location *	WS
Category	Supplemental			GPS Latitude/Longitude	
				Start	End
Item	DWR Erosion Survey			37.936821 °	37.936821 °
				-121.334582 °	-121.334582 °
DWR ID	RD0524U01RM41.39				
Comment Code					
Inspector Comment					
09/13/2017: No significant change observed.					
07/25/2016: No significant change observed.					
06/24/2015: No significant change observed.					
06/19/2014: No significant change observed.					
08/13/2013: No significant change at this site.					
08/07/2012: The site has been visited by boat survey. No significant change observed.					
08/23/2011: The site is located immediately upstream of a Railroad bridge. Dense vegetation at the water line blocks the view of erosion.					
[2017 Site ID:RD0524U01RM41.39]

Front view of the erosion site. Vegetation is visible.

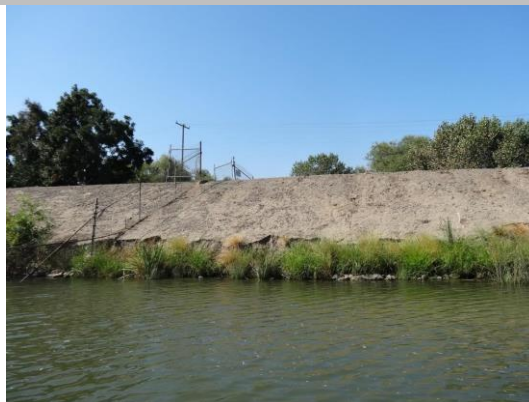
Photo 4 of 4 : SP\_2019\_RD0524\_107\_21\_20190313\_00033.jpg

LM Start	0.76	Rating **	U	Issue No.	21 (cont)	
LM End	0.77	Issue Type +	Ma	Location *	WS	
Category	Supplemental			GPS Latitude/Longitude		
				Start	End	
Item	DWR Erosion Survey			37.936821 °	37.936821 °	
				-121.334582 °	-121.334582 °	
DWR ID	RD0524U01RM41.39					
Comment Code						
Inspector Comment						
09/13/2017: No significant change observed.						
07/25/2016: No significant change observed.						
06/24/2015: No significant change observed.						
06/19/2014: No significant change observed.						
08/13/2013: No significant change at this site.						
08/07/2012: The site has been visited by boat survey. No significant change observed.						
08/23/2011: The site is located immediately upstream of a Railroad bridge. Dense vegetation at the water line blocks the view of erosion.						
[2017 Site ID:RD0524U01RM41.39]

Front view of the erosion.

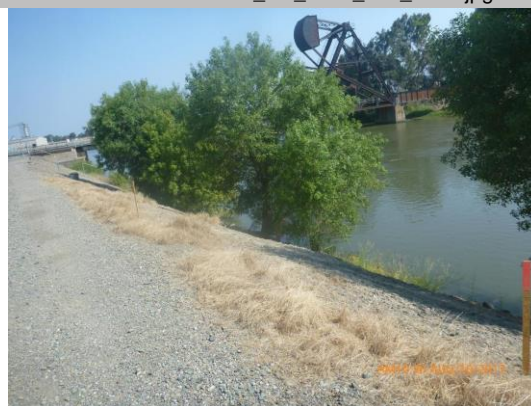
Photo 1 of 3 : LEVAL\_SP\_2019\_538\_4097.jpg

LM Start	0.79	Rating **	A/W	Issue No.	155
LM End	0.80	Issue Type +	Ma	Location *	WS
Category	Supplemental			GPS Latitude/Longitude	
				Start	End
Item	2017 Storm Damage			37.936300 °	37.936200 °
				-121.334700 °	-121.334600 °
DWR ID	DWR_RD0524_01_f_2017_155				
Comment Code					
Inspector Comment					
Levee Evaluation Comments					
Description:Slope protection repairs are needed along the waterside slope due to erosion and riprap displacement from high water. Based upon levee inspections, it was determined the waterside levee slope is eroding, deteriorating, and degrading. The eroded levee sections need to be restored back to design standards to prevent further deterioration and damage.					
Site ID No:538					
Site Designation:LMA-444					
Repair Type: Erosion					
Rating:Area of Concern					
Field Date:8/10/2017					
Notes:

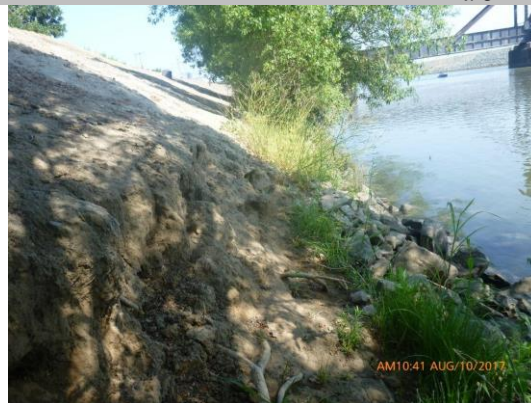
Photo 3 of 3 : LEVAL\_SP\_2019\_538\_4099.jpg

LM Start	0.79	Rating **	A/W	Issue No.	155 (cont)
LM End	0.80	Issue Type +	Ma	Location *	WS
Category	Supplemental			GPS Latitude/Longitude	
				Start	End
Item	2017 Storm Damage			37.936300 °	37.936200 °
				-121.334700 °	-121.334600 °
DWR ID	DWR_RD0524_01_f_2017_155				
Comment Code					
Inspector Comment					
Levee Evaluation Comments					
Description:Slope protection repairs are needed along the waterside slope due to erosion and riprap displacement from high water. Based upon levee inspections, it was determined the waterside levee slope is eroding, deteriorating, and degrading. The eroded levee sections need to be restored back to design standards to prevent further deterioration and damage.					
Site ID No:538					
Site Designation:LMA-444					
Repair Type: Erosion					
Rating:Area of Concern					
Field Date:8/10/2017					
Notes:

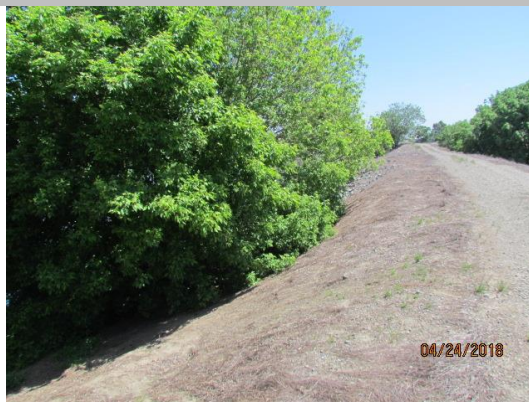
Photo 1 of 1 : SP\_2019\_RD0524\_107\_149\_20190313\_00149.jpg

LM Start	0.90	Rating **	M	Issue No.	149
LM End	0.90	Issue Type +	Ma	Location *	WS
Category	Earthen Levee			GPS Latitude/Longitude	
				Start	End
Item	Trim / Thin Trees			37.935319 °	37.935319 °
				-121.333406 °	-121.333406 °
DWR ID	DWR_RD0524_01_s_2018_149				
Comment Code					
T1 : Trim trees to at least five feet above ground level.					
Inspector Comment

Looking southeast at untrimmed trees on waterward slope. (Spring 2018)

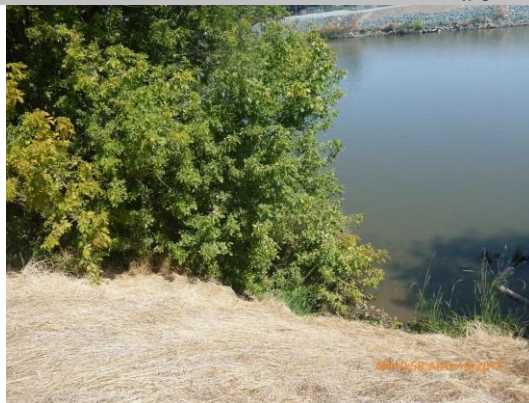
Photo 3 of 3 : LEVAL\_SP\_2019\_537\_4104.jpg

LM Start	0.90	Rating **	A/W	Issue No.	193 (cont)
LM End	0.91	Issue Type +	Ma	Location *	
Category	Supplemental			GPS Latitude/Longitude	
				Start	End
Item	2017 Storm Damage			37.935400 °	37.935300 °
				-121.333300 °	-121.333200 °
DWR ID	DWR_RD0524_01_f_2017_193				
Comment Code					
Inspector Comment					
Levee Evaluation Comments					
Description:Slope protection repairs are needed along the waterside slope due to erosion and riprap displacement from high water. Based upon levee inspections, it was determined the waterside levee slope is eroding, deteriorating, and degrading. The eroded levee sections need to be restored back to design standards to prevent further deterioration and damage.					
Site ID No:537					
Site Designation:LMA-443					
Repair Type: Erosion					
Rating:Serious					
Field Date:8/10/2017					
Notes:

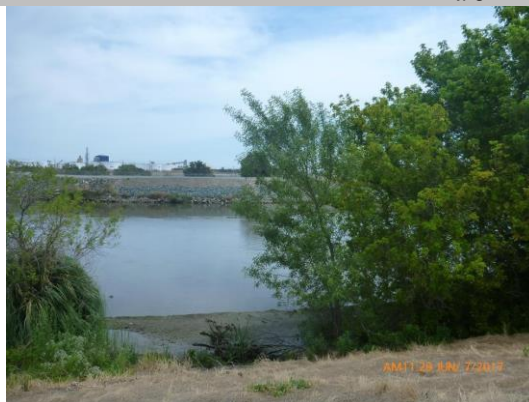
Photo 1 of 3 : LEVAL\_SP\_2019\_87\_1285.jpg

LM Start	0.91	Rating **	A/W	Issue No.	187	
LM End		Issue Type +	Ma	Location *		
Category	Supplemental			GPS Latitude/Longitude		
				Start	End	
Item	2017 Storm Damage			37.935580	°	°
				-121.333200	°	°
DWR ID	DWR_RD0524_01_f_2017_187					
Comment Code						
Inspector Comment						
Levee Evaluation Comments						
Description:						
Site ID No:87						
Site Designation:DWR_RD0524_01_s_2012_99						
Repair Type: Erosion						
Rating:Area of Concern						
Field Date:6/7/2017						
Notes: no observable defects to levee, vegetation blocks ws toe

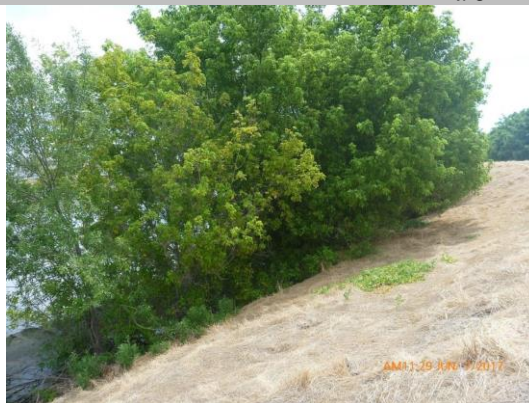
Photo 2 of 3 : LEVAL\_SP\_2019\_87\_1286.jpg

LM Start	0.91	Rating **	A/W	Issue No.	187 (cont)	
LM End		Issue Type +	Ma	Location *		
Category	Supplemental			GPS Latitude/Longitude		
				Start	End	
Item	2017 Storm Damage			37.935580 °		°
				-121.333200 °		°
DWR ID	DWR_RD0524_01_f_2017_187					
Comment Code						
Inspector Comment						
Levee Evaluation Comments						
Description:						
Site ID No:87						
Site Designation:DWR_RD0524_01_s_2012_99						
Repair Type: Erosion						
Rating:Area of Concern						
Field Date:6/7/2017						
Notes: no observable defects to levee, vegetation blocks ws toe

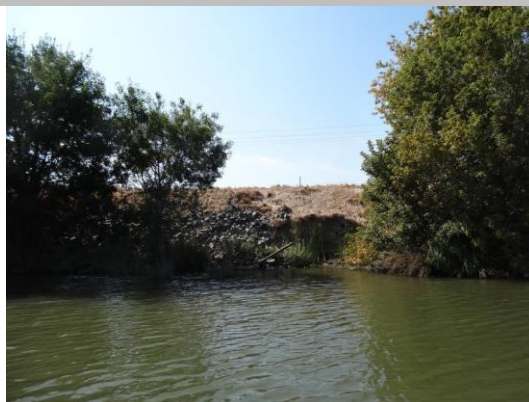
Photo 2 of 3 : SP\_2019\_RD0524\_107\_29\_20190313\_00045.jpg

LM Start	0.91	Rating **	U	Issue No.	29
LM End	0.91	Issue Type +	Ma	Location *	WS
Category	Supplemental			GPS Latitude/Longitude	
				Start	End
Item	DWR Erosion Survey			37.935576 °	37.935576 °
				-121.333202 °	-121.333202 °
DWR ID	RD0524U01RM41.5				
Comment Code					
Inspector Comment					
09/13/2017: No significant change observed.					
07/25/2016: No significant change observed.					
06/24/2015: No significant change observed.					
06/19/2014: No significant change observed.					
08/13/2013: No significant change at this site.					
08/07/2012: The site has been visited by boat survey. No significant change observed					
08/23/2011: The erosion site is immediately downstream of the riprap protection. [2017 Site ID:RD0524U01RM41.5]

Close view of the erosion.

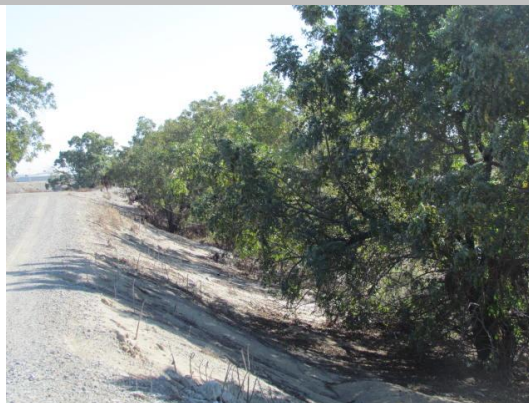
Photo 1 of 1 : SP\_2019\_RD0524\_107\_77\_20190313\_00106.jpg

LM Start	0.93	Rating **	U	Issue No.	77
LM End	1.01	Issue Type +	Ma	Location *	LS
Category	Earthen Levee			GPS Latitude/Longitude	
				Start	End
Item	Trim / Thin Trees			37.935259 °	37.935049 °
				-121.332864 °	-121.331334 °
DWR ID	DWR_RD0524_01_s_2012_77				
Comment Code					
T1 : Trim trees to at least five feet above ground level.					
Inspector Comment

Looking south at low hanging tree branches at landside toe.

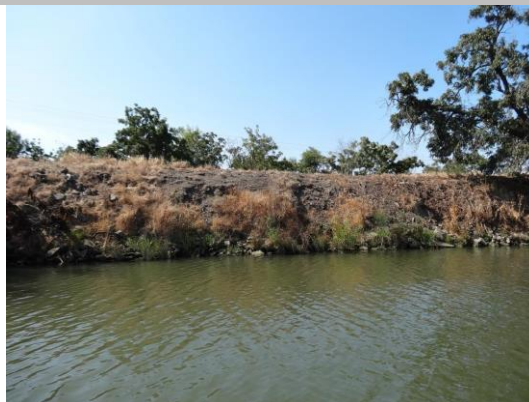
Photo 2 of 4 : SP\_2019\_RD0524\_107\_30\_20190313\_00048.jpg

LM Start	1.00	Rating **	U	Issue No.	30
LM End	1.00	Issue Type +	Ma	Location *	WS
Category	Supplemental			GPS Latitude/Longitude	
				Start	End
Item	DWR Erosion Survey			37.935410 °	37.935410 °
				-121.331560 °	-121.331560 °
DWR ID	RD0524U01RM41.58				
Comment Code					
Inspector Comment					
09/13/2017: No significant change observed.					
07/25/2016: No significant change observed.					
06/24/2015: No significant change observed.					
06/19/2014: No significant change observed.					
08/13/2013: No significant change at this site.					
08/07/2012: The erosion was discovered during the boat survey. [2017					
Site ID:RD0524U01RM41.58]

Close view of the erosion.

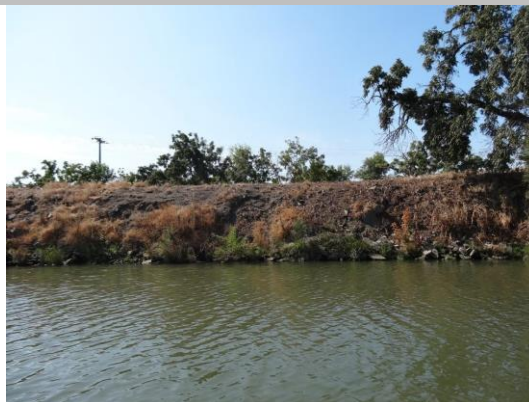
Photo 3 of 4 : SP\_2019\_RD0524\_107\_30\_20190313\_00049.jpg

Front view of the erosion.

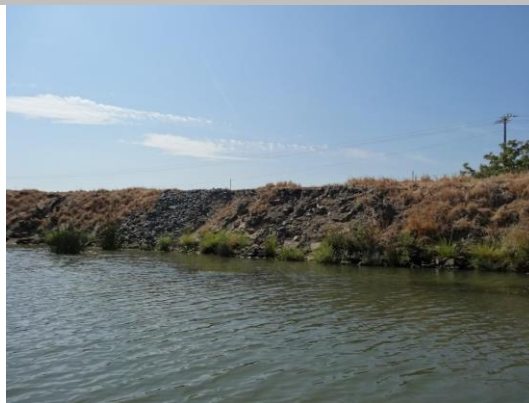
Photo 1 of 3 : SP\_2019\_RD0524\_107\_33\_20190313\_00051.jpg

LM Start	1.02	Rating **	U	Issue No.	33
LM End	1.02	Issue Type +	Ma	Location *	WS
Category	Supplemental			GPS Latitude/Longitude	
				Start	End
Item	DWR Erosion Survey			37.935078 °	37.935078 °
				-121.331134 °	-121.331134 °
DWR ID	RD0524U01RM41.59				
Comment Code					
Inspector Comment					
09/13/2017: No significant change observed.					
07/25/2016: No significant change observed.					
06/24/2015: No significant change observed.					
06/19/2014: No significant change observed.					
08/13/2013: No significant change at this site.					
08/07/2012: The site has been visited by boat survey. Site has been repaired, but new erosion occurred at the levee slope and immediately upstream of the repaired site.					
08/23/2011: The site is about 500 ft downstream of bridge. The levee toe seems to be protected, but the protection is being washed away.					
[2017 Site ID:RD0524U01RM41.59]

Upstream view of the site.

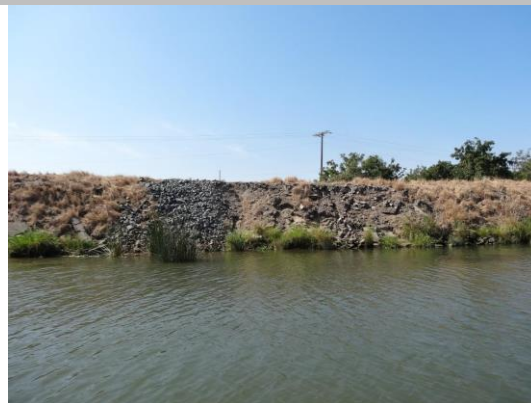
Photo 3 of 3 : SP\_2019\_RD0524\_107\_33\_20190313\_00053.jpg

Comment Code						
Inspector Comment						
09/13/2017: No significant change observed.						
07/25/2016: No significant change observed.						
06/24/2015: No significant change observed.						
06/19/2014: No significant change observed.						
08/13/2013: No significant change at this site.						
08/07/2012: The site has been visited by boat survey. Site has been repaired, but new erosion occurred at the levee slope and immediately upstream of the repaired site.						
08/23/2011: The site is about 500 ft downstream of bridge. The levee toe seems to be protected, but the protection is being washed away.						
[2017 Site ID:RD0524U01RM41.59]

Front view of the site.

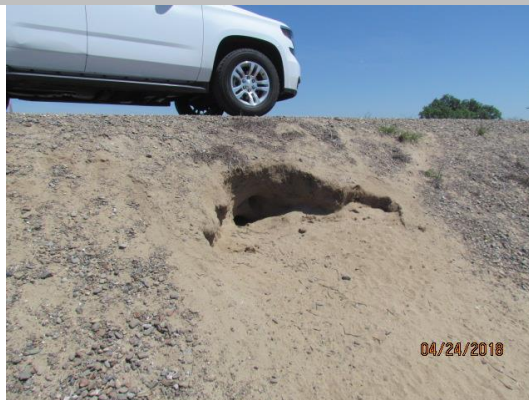
Photo 2 of 3 : SP\_2019\_RD0524\_107\_238\_20190313\_00259.jpg

LM Start	1.02	Rating **	U	Issue No.	238 (cont)	
LM End	1.02	Issue Type +	Ma	Location *	LS	
Category	Earthen Levee			GPS Latitude/Longitude		
				Start		End
Item	Animal Control			37.934991 °		37.934991 °
				-121.331160 °		-121.331160 °
DWR ID	DWR_RD0524_01_f_2017_238					
Comment Code						
A3 : No rodents visible, but rodent burrows visible; need to backfill and compact or grout burrows.						
Inspector Comment						
Multiple large rodent holes on landward slope and toe. Large hole on crown near landside shoulder

Looking east at large rodent hole on landward slope. (Spring 2018)

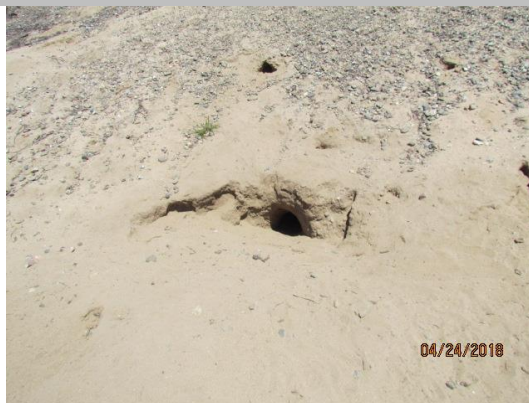
Photo 3 of 3 : SP\_2019\_RD0524\_107\_238\_20190313\_00260.jpg

Looking northeast at rodent hole on landward slope. (Spring 2018)

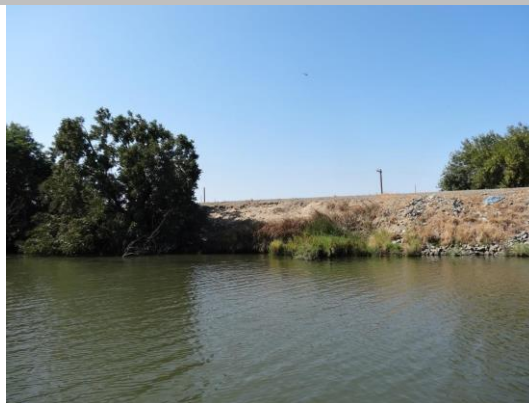
Photo 1 of 4 : SP\_2019\_RD0524\_107\_44\_20190313\_00058.jpg

Comment Code					
Inspector Comment					
09/13/2017: No significant change observed.					
07/25/2016: No significant change observed.					
06/24/2015: No significant change observed.					
06/19/2014: No significant change observed.					
08/13/2013: No significant change at this site.					
08/07/2012: The site has been visited by boat survey. No significant change observed					
08/23/2011: No significant change observed on site.					
09/07/2010: No significant change observed on site. Vegetation is visible at the water line. There is an exposed pipe discharge partially hanging at the mid-slope, possibly still used for discharging irrigation/runoff water. There is minimal rip rap protection along the bank, and what's left of it is no longer adequately protecting the bank.					
9/29/2009: Site consists of a 400-foot long eroding bank with minimal vegetation and protection; the existing rip rap has sloughed, rendering it useless; note that there is an exposed section of a pipe.

Direct view of the site.

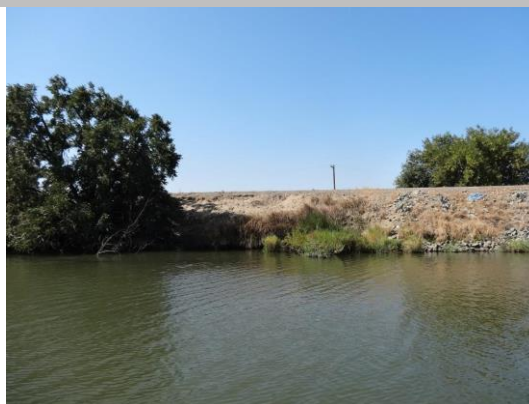
Photo 2 of 4 : SP\_2019\_RD0524\_107\_44\_20190313\_00059.jpg

Direct view of the site.

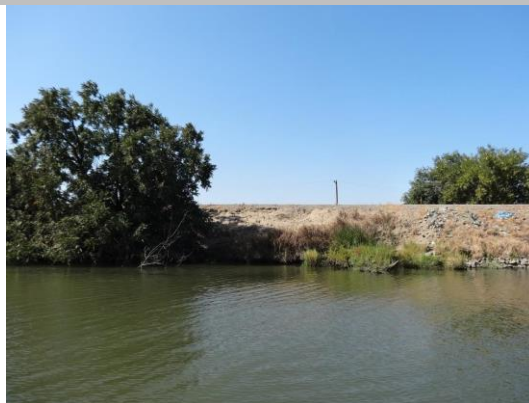
Photo 3 of 4 : SP\_2019\_RD0524\_107\_44\_20190313\_00060.jpg

Comment Code						
Inspector Comment						
09/13/2017: No significant change observed.						
07/25/2016: No significant change observed.						
06/24/2015: No significant change observed.						
06/19/2014: No significant change observed.						
08/13/2013: No significant change at this site.						
08/07/2012: The site has been visited by boat survey. No significant change observed						
08/23/2011: No significant change observed on site.						
09/07/2010: No significant change observed on site. Vegetation is visible at the water line. There is an exposed pipe discharge partially hanging at the mid-slope, possibly still used for discharging irrigation/runoff water. There is minimal rip rap protection along the bank, and what's left of it is no longer adequately protecting the bank.						
9/29/2009: Site consists of a 400-foot long eroding bank with minimal vegetation and protection; the existing rip rap has sloughed, rendering it useless; note that there is an exposed section of a pipe.

10/18/2006: There is extensive loss of rip rap on some sections; sewage disposal pond is on the landside of the levee; there is an exposed pipe outlet "hanging" from the upper slope. [2017 Site ID:RD0524U01RM41.79]

View of the erosion.

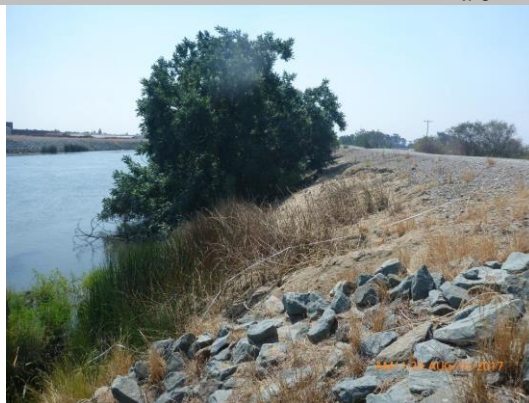
Photo 1 of 3 : LEVAL\_SP\_2019\_535\_4115.jpg

LM Start	1.18	Rating **	A/W	Issue No.	221
LM End	1.20	Issue Type +	Ma	Location *	
Category	Supplemental			GPS Latitude/Longitude	
				Start	End
Item	2017 Storm Damage			37.933500 °	37.933200 °
				-121.329100 °	-121.328900 °
DWR ID	DWR_RD0524_01_f_2017_221				
Comment Code					
Inspector Comment					
Levee Evaluation Comments					
Description:Slope protection repairs are needed along the waterside slope due to erosion and riprap displacement from high water. Based upon levee inspections, it was determined the waterside levee slope is eroding, deteriorating, and degrading. The eroded levee sections need to be restored back to design standards to prevent further deterioration and damage.					
Site ID No:535					
Site Designation:LMA-441					
Repair Type: Erosion					
Rating:Area of Concern					
Field Date:8/10/2017					
Notes:

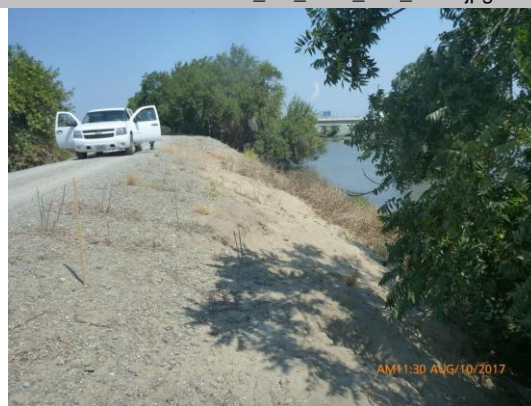
Photo 3 of 3 : LEVAL\_SP\_2019\_535\_4117.jpg

LM Start	1.18	Rating **	A/W	Issue No.	221 (cont)	
LM End	1.20	Issue Type +	Ma	Location *		
Category	Supplemental			GPS Latitude/Longitude		
				Start	End	
Item	2017 Storm Damage			37.933500 °	37.933200 °	
				-121.329100 °	-121.328900 °	
DWR ID	DWR_RD0524_01_f_2017_221					
Comment Code						
Inspector Comment						
Levee Evaluation Comments						
Description:Slope protection repairs are needed along the waterside slope due to erosion and riprap displacement from high water. Based upon levee inspections, it was determined the waterside levee slope is eroding, deteriorating, and degrading. The eroded levee sections need to be restored back to design standards to prevent further deterioration and damage.						
Site ID No:535						
Site Designation:LMA-441						
Repair Type: Erosion						
Rating:Area of Concern						
Field Date:8/10/2017						
Notes:

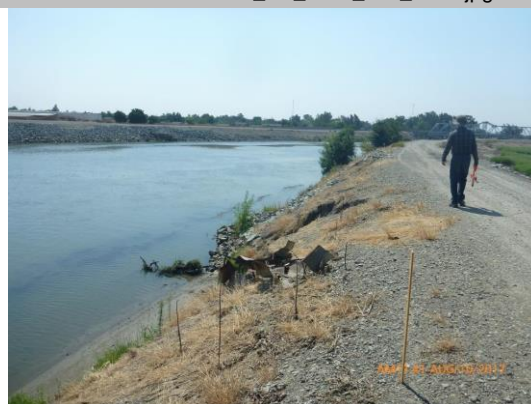
Photo 1 of 3 : LEVAL\_SP\_2019\_534\_4121.jpg

Comment Code					
Inspector Comment					
Levee Evaluation Comments					
Description:Slope protection repairs are needed along the waterside slope due to erosion and riprap displacement from high water. Based upon levee inspections, it was determined the waterside levee slope is eroding, deteriorating, and degrading. The eroded levee sections need to be restored back to design standards to prevent further deterioration and damage.					
Site ID No:534					
Site Designation:LMA-440					
Repair Type: Erosion					
Rating:Serious					
Field Date:8/10/2017					
Notes: site is related to, but not combined with, LMA-439 a portion of this site has been repaired.

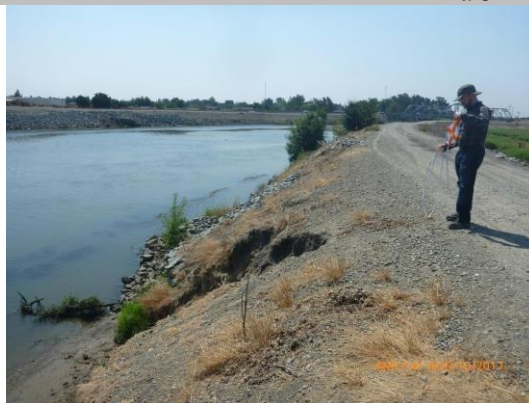
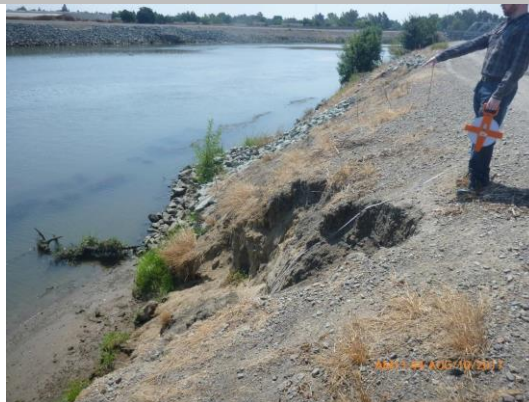
LM Start	<b>1.25</b>	Rating **	A/W	Issue No.	<b>222 (cont)</b>
LM End	<b>1.30</b>	Issue Type +	Ma	Location *

Item	2017 Storm Damage			37.932600 °	37.931900 °	
				-121.328700 °	-121.328400 °	
DWR ID	DWR_RD0524_01_f_2017_222					
Comment Code						
Inspector Comment						
Levee Evaluation Comments						
Description:Slope protection repairs are needed along the waterside slope due to erosion and riprap displacement from high water. Based upon levee inspections, it was determined the waterside levee slope is eroding, deteriorating, and degrading. The eroded levee sections need to be restored back to design standards to prevent further deterioration and damage.						
Site ID No:534						
Site Designation:LMA-440						
Repair Type: Erosion						
Rating:Serious						
Field Date:8/10/2017						
Notes: site is related to, but not combined with, LMA-439 a portion of this site has been repaired.

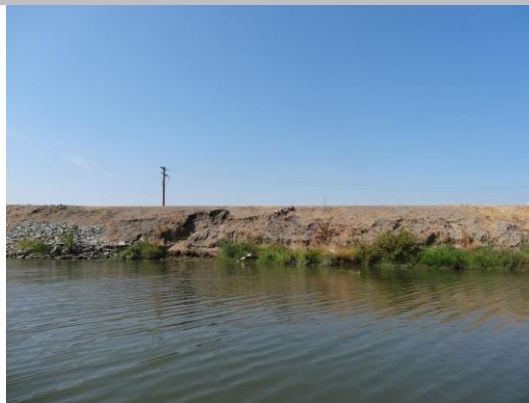
Photo 3 of 4 : SP\_2019\_RD0524\_107\_47\_20190313\_00068.jpg

LM Start	1.27	Rating **	A/W	Issue No.	47 (cont)
LM End	1.30	Issue Type +	Ma	Location *	WS
Category	Supplemental			GPS Latitude/Longitude	
				Start	End
Item	DWR Erosion Survey			37.931858 °	37.931887 °
				-121.328300 °	-121.328343 °
DWR ID	RD0524U01RM41.92				
Comment Code					
Inspector Comment					
5/17/2018. LM 1.30-1.31 was repaired by DWR the remainder of the site was un affected.					
09/13/2017. The erosion has developed along the levee slope. The length of the erosion is nearly doubled comparing to the prior survey.					
07/25/2016: No significant change observed.					
06/24/2015: No significant change observed.					
06/19/2014: No significant change observed.					
08/13/2013: New signs of animal activity were found.					
08/07/2012: The site was first reported in 2012 spring levee inspection report. [2017 Site ID:RD0524U01RM41.92]

Close view of the erosion.

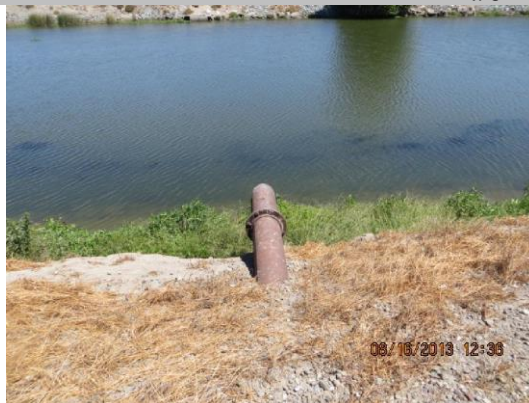
Photo 1 of 3 : UCIP\_SP\_2019\_53162\_29862.jpg

Comment Code					
Inspector Comment					
FS_ID:53162 DS_ID:20602 EP_NO: N/A Repair Type: Non-Urgent Crossing Status: Found UCIP Comments: 10/2/2018 Pipe appears abandoned, but both the pipe and levee appear in good condition; downgrading to Non-Urgent (D. Sanoski - DWR UCIP).11/16/2016 same as previous inspection both ends are open. This pipe does not appear in use. Need to contact owner to determine status of crossing. If the crossing is abandoned or in use, owner will need to coordinate with the CVFPB to comply with Title 23 requirements. (O. Magana - DWR UCIP)08/16/2013 Pipe appears to be open on both ends. Abandoned and should be done so properly. (W. Wylie - DWR UCIP) FIELD_STRUCT_DESC: *ABANDONED* 12-inch steel drainage pipe through the levee, 3.5 feet below the crown. Pipe is opened on the waterside (WS) and landside (LS) ends. The pump house referenced in O&M manual is missing from the LS (2013). [Additional Reference(s): DWR Levee Log, 2004. USACE San Joaquin O&M Manual 7, April 1964, (HLM 1.31)]. FS Date: 10/2/2018 1:10:16 PM

Pipe visible and open on WS slope.

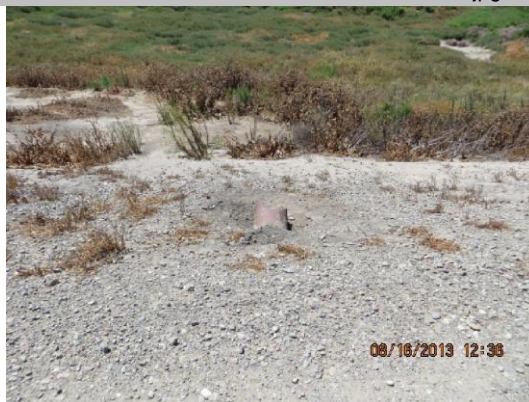
Photo 2 of 3 : UCIP\_SP\_2019\_53162\_29861.jpg

Pipe open and visible on LS slope.

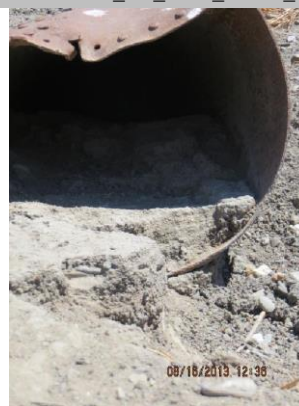
Photo 3 of 3 : UCIP\_SP\_2019\_53162\_29860.jpg

Comment Code						
Inspector Comment						
FS_ID:53162 DS_ID:20602 EP_NO: N/A Repair Type: Non-Urgent Crossing Status: Found UCIP Comments: 10/2/2018 Pipe appears abandoned, but both the pipe and levee appear in good condition; downgrading to Non-Urgent (D. Sanoski - DWR UCIP).11/16/2016 same as previous inspection both ends are open. This pipe does not appear in use. Need to contact owner to determine status of crossing. If the crossing is abandoned or in use, owner will need to coordinate with the CVFPB to comply with Title 23 requirements. (O. Magana - DWR UCIP)08/16/2013 Pipe appears to be open on both ends. Abandoned and should be done so properly. (W. Wylie - DWR UCIP) FIELD_STRUCT_DESC: *ABANDONED* 12-inch steel drainage pipe through the levee, 3.5 feet below the crown. Pipe is opened on the waterside (WS) and landside (LS) ends. The pump house referenced in O&M manual is missing from the LS (2013). [Additional Reference(s): DWR Levee Log, 2004. USACE San Joaquin O&M Manual 7, April 1964, (HLM 1.31)]. FS Date: 10/2/2018 1:10:16 PM

Pipe appears open on both ends. View from LS slope.

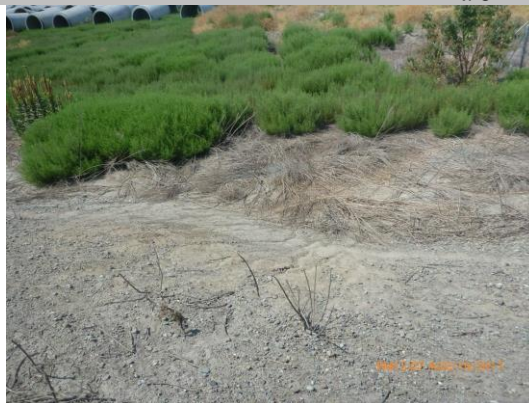
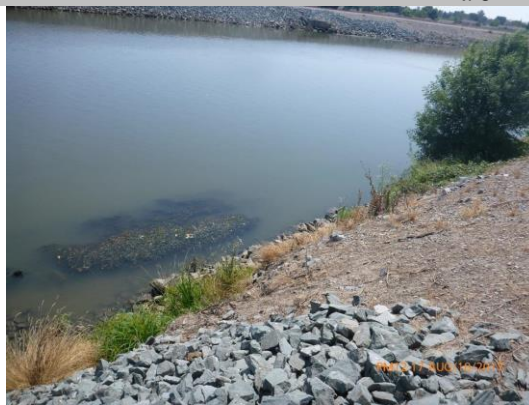
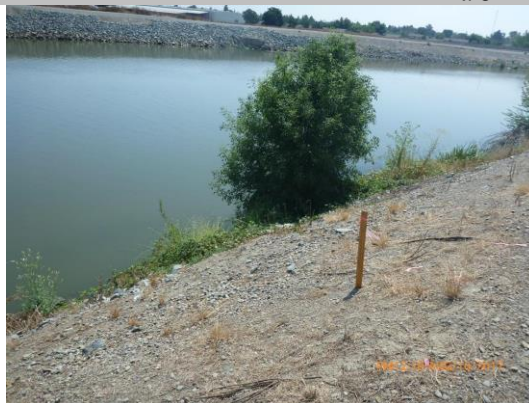
LM Start	1.33	Rating **	A/W	Issue No.	225
LM End	1.33	Issue Type +	Ma	Location *	
Category	Supplemental			GPS Latitude/Longitude	
				Start	End
Item	2017 Storm Damage			37.931500 °	37.931500 °
				-121.328200 °	-121.328200 °
DWR ID	DWR_RD0524_01_f_2017_225				
Comment Code					
Inspector Comment					
Levee Evaluation Comments					
Description:Slope protection repairs are needed along the waterside slope due to erosion and riprap displacement from high water. Based upon levee inspections, it was determined the waterside levee slope is eroding, deteriorating, and degrading. The eroded levee sections need to be restored back to design standards to prevent further deterioration and damage.					
Site ID No:532					
Site Designation:LMA-438					
Repair Type: Erosion					
Rating:Area of Concern					
Field Date:8/10/2017					
Notes:

LM Start	1.33	Rating **	A/W	Issue No.	225 (cont)	
LM End	1.33	Issue Type +	Ma	Location *		
Category	Supplemental			GPS Latitude/Longitude		
				Start	End	
Item	2017 Storm Damage			37.931500 °	37.931500 °	
				-121.328200 °	-121.328200 °	
DWR ID	DWR_RD0524_01_f_2017_225					
Comment Code						
Inspector Comment						
Levee Evaluation Comments						
Description:Slope protection repairs are needed along the waterside slope due to erosion and riprap displacement from high water. Based upon levee inspections, it was determined the waterside levee slope is eroding, deteriorating, and degrading. The eroded levee sections need to be restored back to design standards to prevent further deterioration and damage.						
Site ID No:532						
Site Designation:LMA-438						
Repair Type: Erosion						
Rating:Area of Concern						
Field Date:8/10/2017						
Notes:

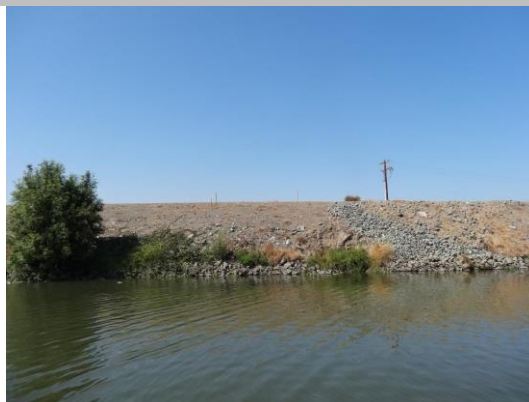
Photo 1 of 2 : SP\_2019\_RD0524\_107\_55\_20190313\_00075.jpg

LM Start	1.33	Rating **	M	Issue No.	55
LM End	1.33	Issue Type +	Ma	Location *	WS
Category	Supplemental			GPS Latitude/Longitude	
				Start	End
Item	DWR Erosion Survey			37.931510 °	37.931510 °
				-121.328120 °	-121.328120 °
DWR ID	RD0524U01RM41.95				
Comment Code					
Inspector Comment					
09/13/2017: The erosion is located immediately upstream of a protected levee section. [2017 Site ID:RD0524U01RM41.95]

Front view of the erosion.

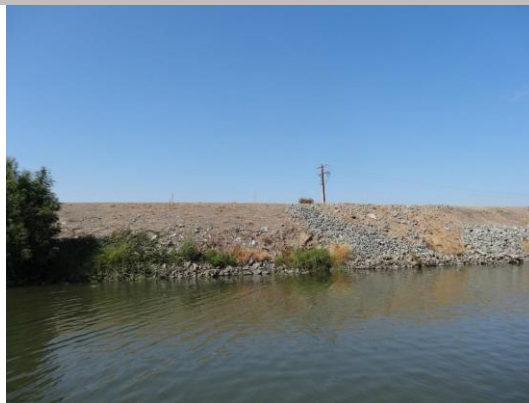
Photo 2 of 2 : SP\_2019\_RD0524\_107\_55\_20190313\_00076.jpg

LM Start	1.33	Rating **	M	Issue No.	55 (cont)	
LM End	1.33	Issue Type +	Ma	Location *	WS	
Category	Supplemental			GPS Latitude/Longitude		
				Start		End
Item	DWR Erosion Survey			37.931510 °		37.931510 °
				-121.328120 °		-121.328120 °
DWR ID	RD0524U01RM41.95					
Comment Code						
Inspector Comment						
09/13/2017: The erosion is located immediately upstream of a protected levee section. [2017 Site ID:RD0524U01RM41.95]

Front view of the erosion.

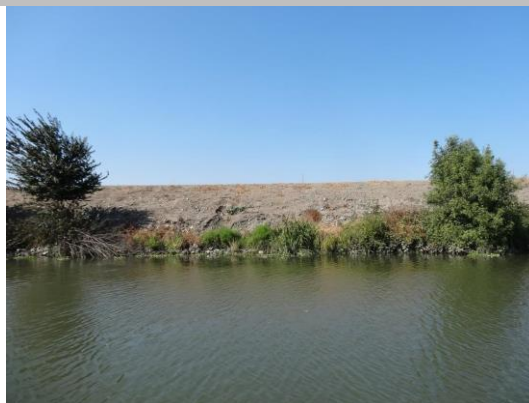
Photo 1 of 3 : SP\_2019\_RD0524\_107\_56\_20190313\_00077.jpg

LM Start	1.39	Rating **	U	Issue No.	56	
LM End	1.39	Issue Type +	Ma	Location *	WS	
Category	Supplemental			GPS Latitude/Longitude		
				Start	End	
Item	DWR Erosion Survey			37.930575	°	37.930575
				-121.328090	°	-121.328090
DWR ID	RD0524U01RM42.03					
Comment Code						
Inspector Comment						
09/13/2017: No significant change observed 07/25/2016: No significant change observed 06/24/2015: No significant change observed. 06/19/2014: No significant change observed. 08/13/2013: No significant change observed. 08/07/2012: The site was first reported in 2012 spring levee inspection report. The site is located about 75 ft downstream of SR 4 Bridge. [2017 Site ID:RD0524U01RM42.03]

Front view of the erosion.
